RE: Safety Recall #800-G
20-EDL Model Ball Sockets
Expiration Date: None

SUBJECT: SAFETY RECALL #800-G
20-EDL MODEL BALL SOCKETS
EXPIRATION DATE: NONE

EDL Socket Replacement (Tie Rods)

EDL Socket Replacement (Drag Links)

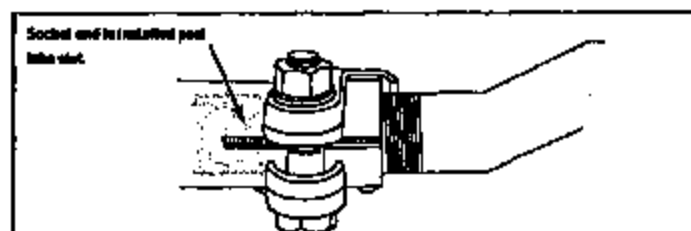
WARNING Do not adjust the drag link to a position where you can see the end of the socket thread through the slot in the tube. If the socket thread end is visible, corrosion may occur in the tube weakening the components.

7. Make sure both ends are threaded into the tube deeper than the slot in the tube.
